H083 MAINTENANCE NOTE NO. 2
(For Electronics Technicians)

2. Transmitter Box Door Seal Repair

H083 MAINTENANCE NOTE NO. 3
(For Electronics Technicians)3.0 H083 Maintenance Updates --Dewpoint Sensor Mirror Cleaning, Dewpoint Sensor
Factory Modification, and "O" Ring Inspections.GENERAL

6. H083 Sensor Optics Alignment

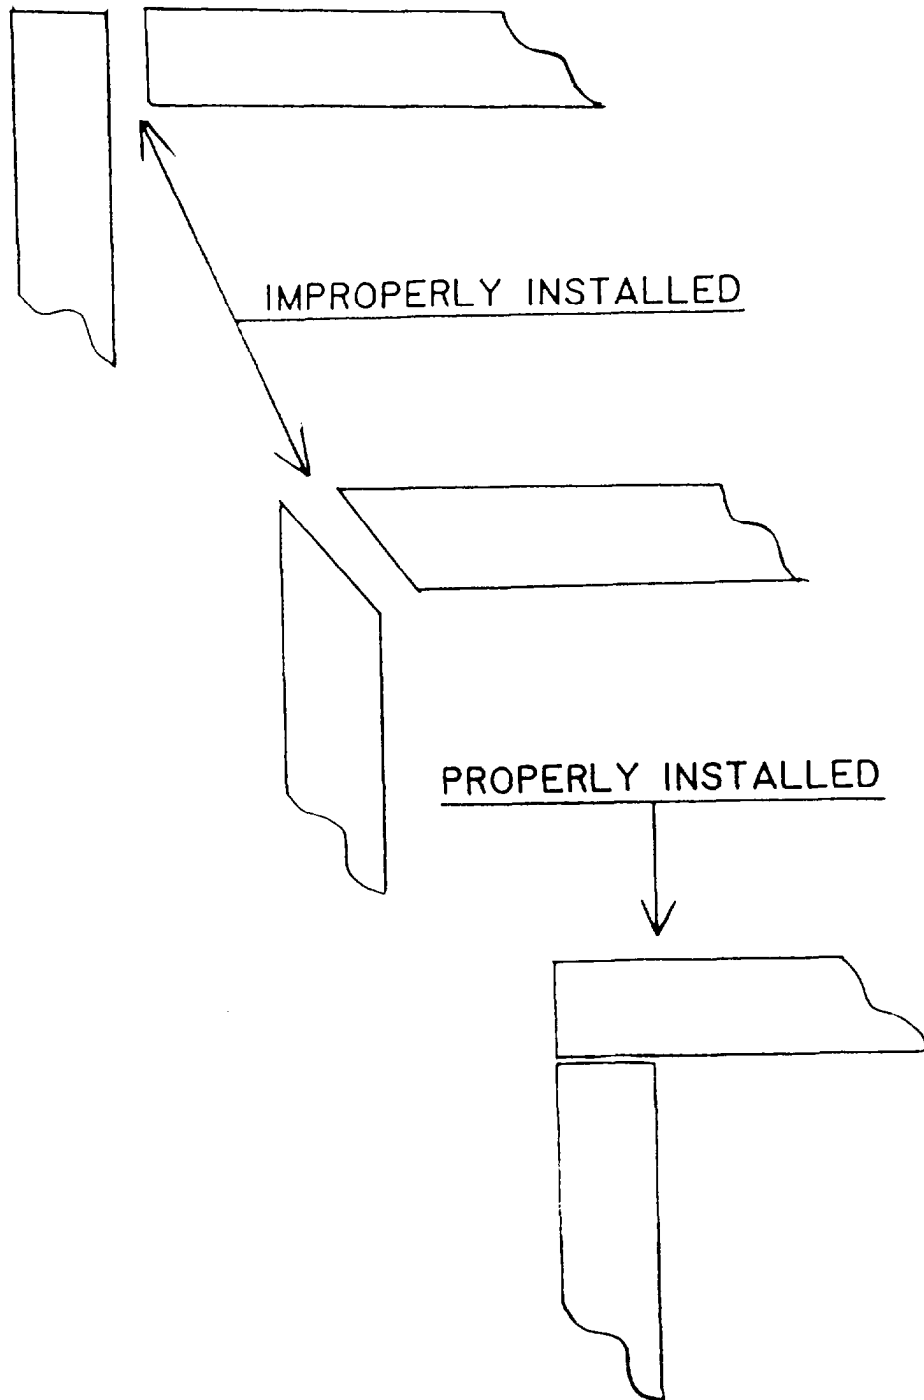
FIGURE 1

This maintenance note contains instructions to correct the problem of water leaking into the H083 transmitter box by application of an RTV sealing compound, for those transmitter door seals that were improperly installed.

HO-83 TRANSMITTER DOOR SEAL

1. Open the transmitter door on the H083.
2. Apply RTV sealing compound liberally filling the gap between adjacent door seals with an excess amount of compound to ensure a good seal.
3. After using wax paper or a thin layer of silicone grease opposite the door seal to act as a mold release, close and secure the transmitter door. Leave in place until fully cured (about 24 hours).
4. After fully cured, remove wax paper or wipe off silicone grease.
